IMPROVED LAYOUT FOR A FOWL PROCESSING PLANT

Marketing Research Report No. 973

Agricultural Research Service
UNITED STATES DEPARTMENT OF AGRICULTURE

By Jesse W. Goble, agricultural marketing specialist, Dairy and Poultry Products Marketiny Laboratory, Northeastern Region, Agricultural Research Service¹

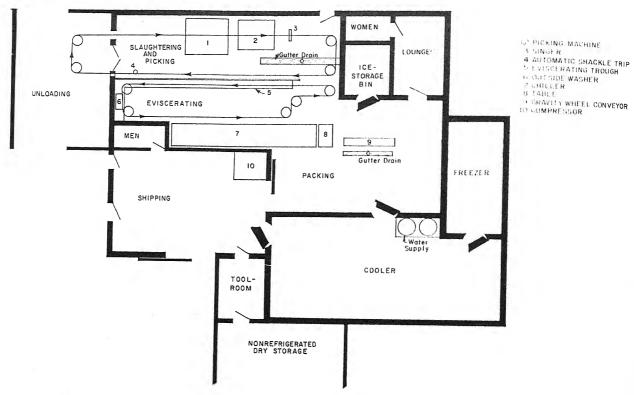
Figure 1.-Layout of the existing plant.

The building (fig. 1) contains 4,786 square feet of floorspace and is constructed at ground level. Because the ground slopes, the floor at one side of the building is at truck-bed height where loading and unloading occur. The building is made of concrete blocks except the dry storage area, which is of wood with a 10-foot-high ceiling. Some room ceilings are 9 and others 13 feet high.

The original structure was enlarged to its present size by making additions on two sides of the building.

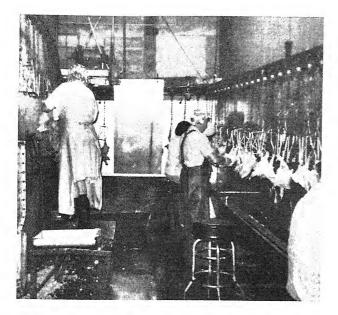
Eviscerating.—The eviscerating area is congested (fig. 2). Water on the floor must pass beneath the metal partition between the slaughtering and picking area and the eviscerating area to reach the gutter drain at the end of the picking area. The ceiling is 13 feet high except for a small area that is only 9 feet high.

Figure 2.—Worker at left removes birds from eviscerating shackles and drops them into the chiller. Note the congestion in the area.

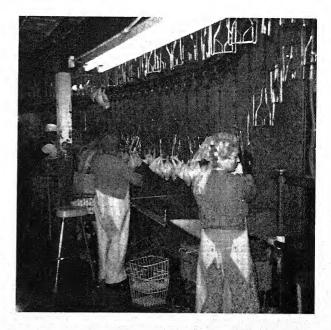
A narrow L-shaped eviscerating trough is located against the metal partition that separates the eviscerating area from the slaughtering and picking area and along the far wall of the eviscerating area (fig. 3). Offal flows from the forward end of the eviscerating trough into a perforated container, which allows the water to drain onto the floor. Periodically the offal is

Figure 3.—One section of L-shaped eviscerating trough is next to metal partition.

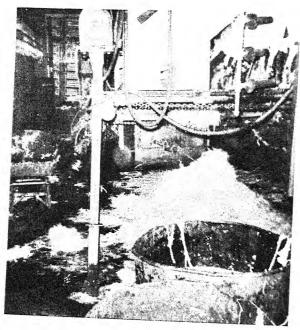
removed manually from the container and held temporarily in barrels located in the picking area near the picking machine (fig. 4).

Figure 4.—Offal is accumulated in barrels near the picking machine.

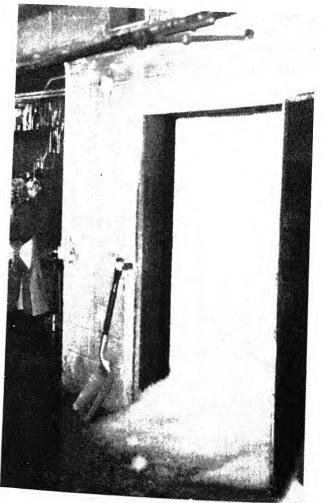
A flake ice machine is located on the roof above the packing area so the ice can drop into the storage bin, which is at floor level adjacent to the packing area. When the door to the icestorage bin is opened, ice often spills out onto the floor of the packing area (fig. 5). The toolroom adjoins the shipping area and provides the only access to the nonrefrigerated dry storage area, which is behind the toolroom.

Figure 5.—Ice is discharged onto floor of packing area when door of ice-storage bin is opened.
